RCAR Design Guide - A manufacturers' guide to ensure good design practice for repairability and limitation of damage.

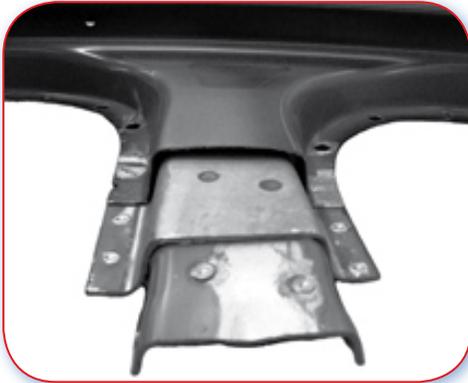
A.1.1 Poor example. Subsequent panels can be damaged during sectioning.

Design for repair guidance: Allow enough space for tooling between the panels for sectioning in likely areas of repair, as specified in existing repair manuals (pic A.1.1).

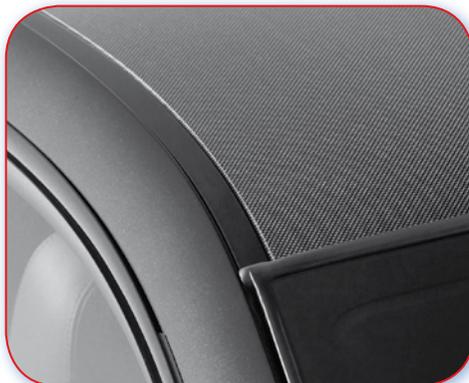
A.8.1 Composite roof.

also be an advantage, as damage to cosmetic composite panels can be easily detected (pic A.8.1).

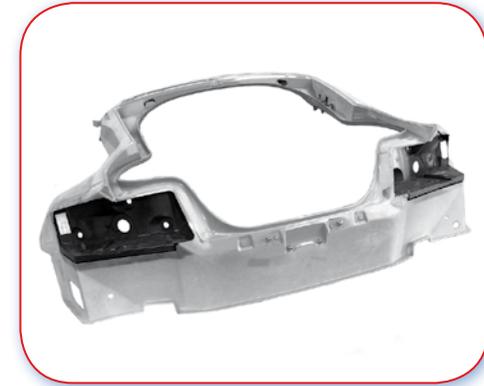
A.8.2 Single piece SMC boot surround.

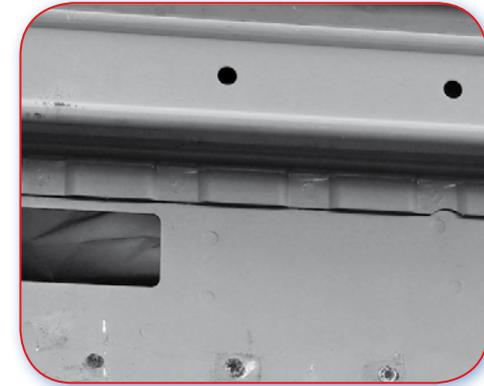
B.2.1 Poor example. Locations for new spot welds limited, due to shape of flange.

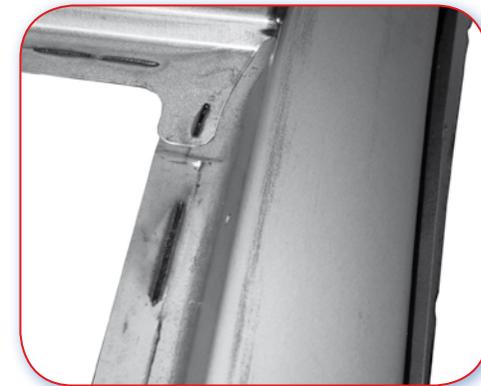
B.11.1 General example of laser welding applied close to flange edge.

Effect on repair: Laser welding requires a small flange on panels, meaning that when this panel is replaced with spot welding, there is not enough space to fit a spot weld properly.

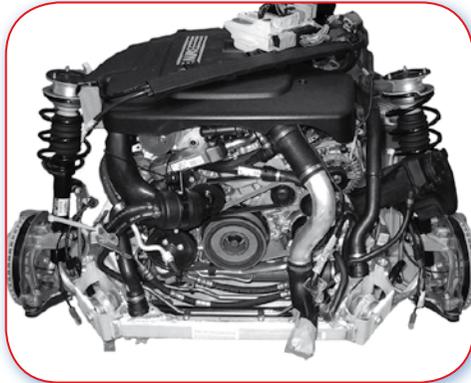
C.1.1 Good example. Complete removal of engine.

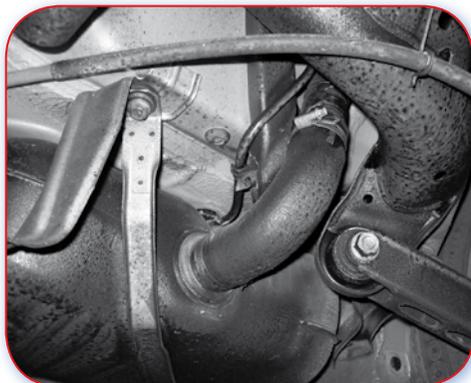
C.2.1 Fuel filler neck and fuel tank joint with removable elbow, allowing it to be separated.

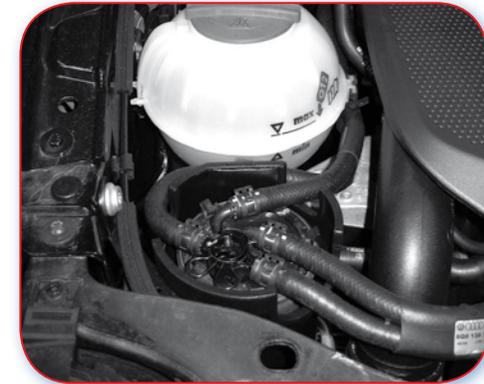
C.4.1 Poor example. Expensive auxiliary units positioned in vulnerable areas.

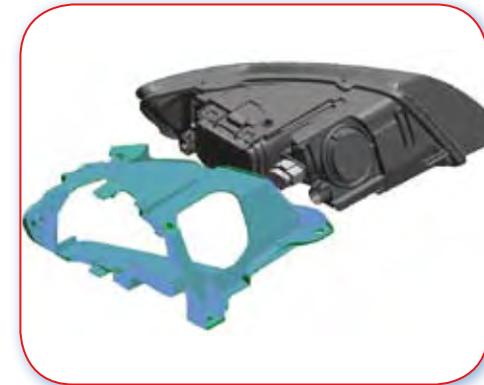
C.5.1 Good example. Light cluster (in grey) removed from bracket (green). Source: Audi AG.

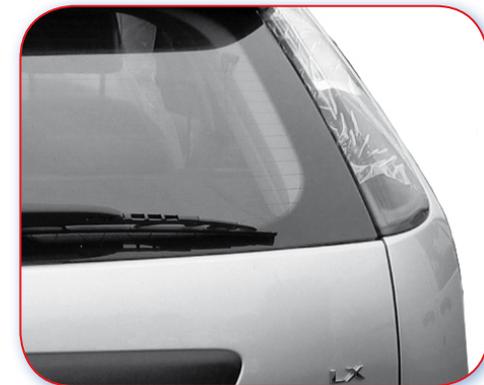
C.6.1 Good example. A light cluster fitted in a higher position avoids damage on impact.

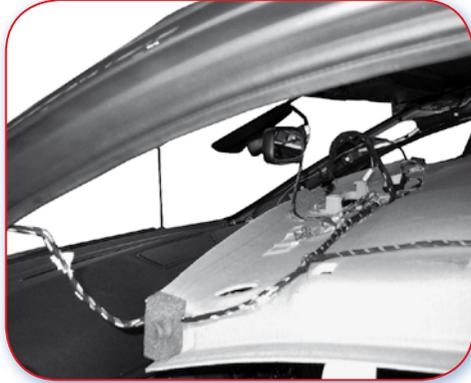
C.7.1 Poor example. Parts and looms that cannot be detached.

Effect on repair: Parts containing electrical units, mainly trim panels, need to be removed when repair on adjacent panels is required. Frequently, the part can be detached from the panel holding it, but it cannot be separated from the loom. This suits a production system, but is not ideal for repair. It means that the trim panel has to stay in the vehicle which will obstruct the repair procedure. It can also cause damage to the trim panel during repair or require further stripping out. Both will increase repair costs (pic C.7.1, C.7.2).

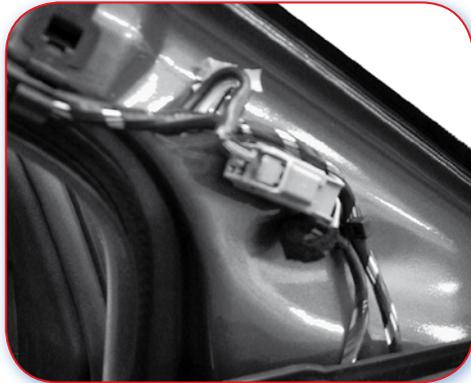
C.7.2 Poor example. Loom partly detachable. Use a larger multi-plug or an additional plug, so both sets of wires can be detached.

Design for repair guidance: The ability to separate parts should be a requirement for the loom design. It could mean either the introduction of connectors in the loom, or the availability of a repair method for a loom, possibly involving the introduction of connectors after the loom has been cut.

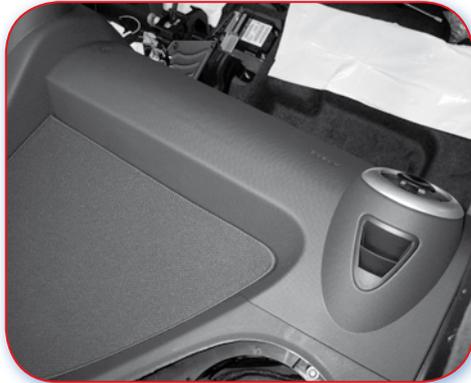
C.13.1 Good example. Facia can be partly removed after being damaged by deployment of airbag.

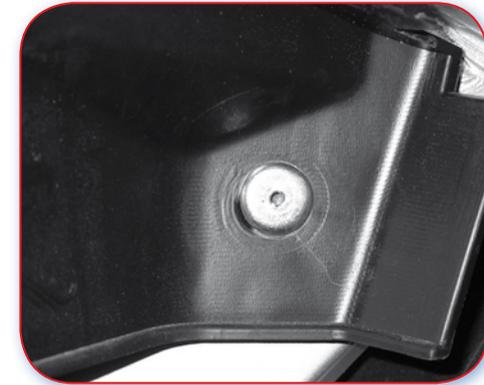
Poor Example. Plastic element fixed with rivets. Removal of the rivets could damage it.

It is advisable to avoid the use of rivets to fix plastic elements to the bodyshell. In general, when removed by drilling out, the rivet will rotate and be difficult to remove. Additionally, the plastic part will be damaged by friction and heat.

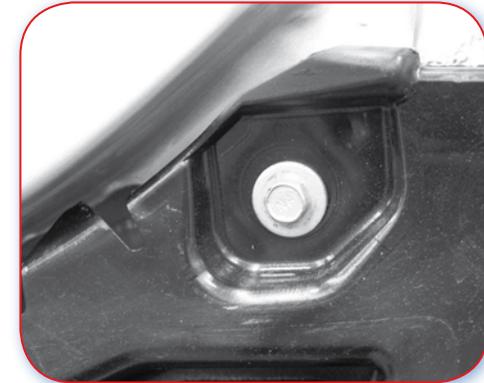
Good Example. Plastic element fixed with screws. Removing the screws is easy and causes no additional problems.

Design for repair guidance: Use a fastener that can be removed without drilling.

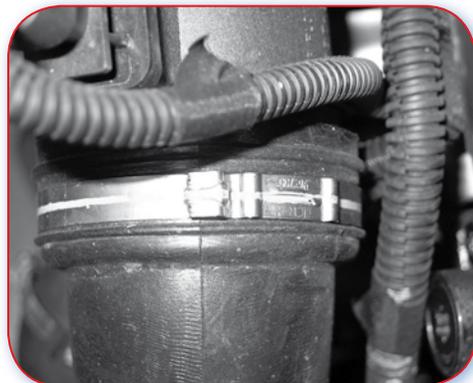
Poor Example. Conventional joints are difficult to remove, especially when access to the clip is restricted.

Use quick release joints in hoses/pipes for the cooling system, air conditioning system and also, if possible, in the exhaust pipe.

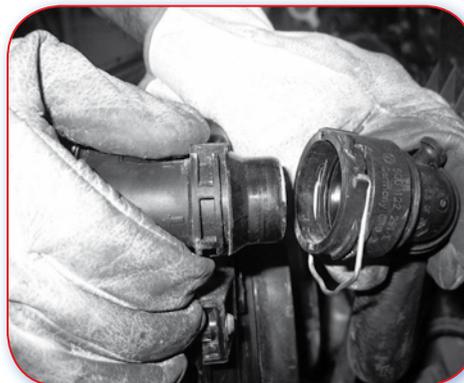
Good Example. Quick plug joints facilitate removal of the mechanical elements.

Design for repair guidance: Introduce reuseable quick release joints on specific systems and locations. (See also the door area within M.E.T.).

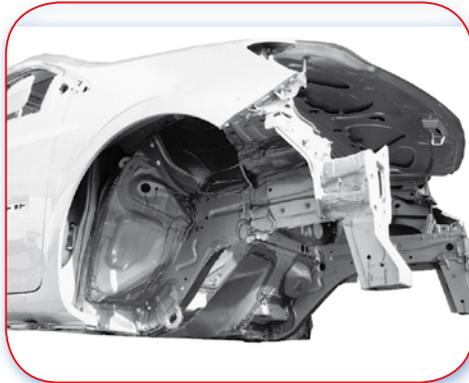
D.1.1 Poor example. Body showing different finishes.

Design for repair guidance: Avoid visible and non-visible surfaces having different paint and finish treatments (pic D.1.1).

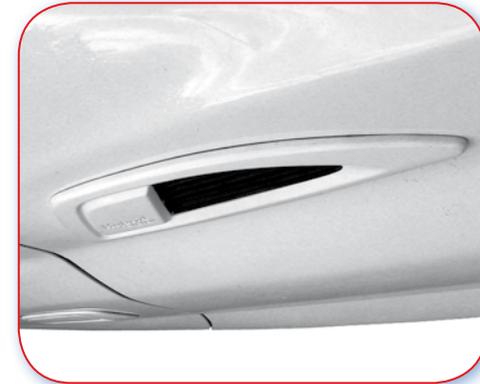
D.4.1 Poor example. A hard plastic insert is difficult to mask around, so it will require removal.

Effect on repair: Any inserts or covers should be detachable from the panel to which they are fitted. When this is not the case, it means that masking is required whilst the retaining panel is painted, requiring extra time. Also, the quality will not be as good as when a panel can be sprayed without any inserts (pic D.4.1).

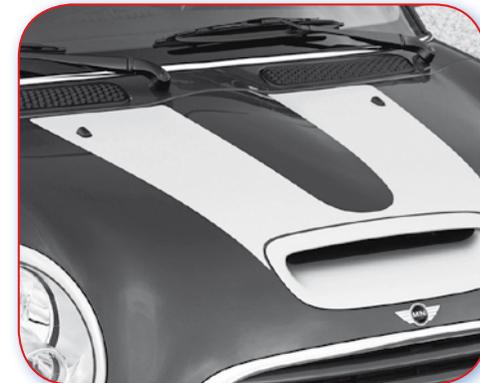
D.5.1 Poor example. A bonnet showing different colours on one panel.

Effect on repair: Two colours on the same panel are difficult to blend in and will always show evidence of repair (pic D.5.1).

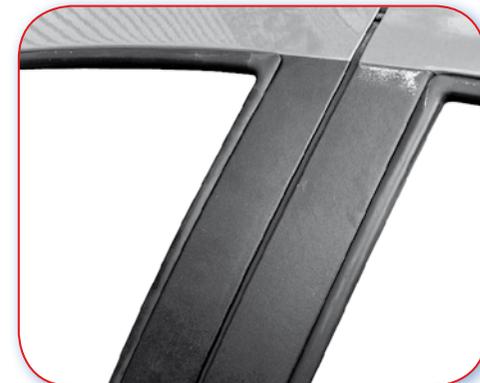
D.6.1 Poor example. Decal applied to door edges.

Effect on repair: Decals are difficult to remove should they need replacing in repair. The application of new decals is problematic as air can often be trapped under the surface, leading to a poor quality repair (pic D.6.1).

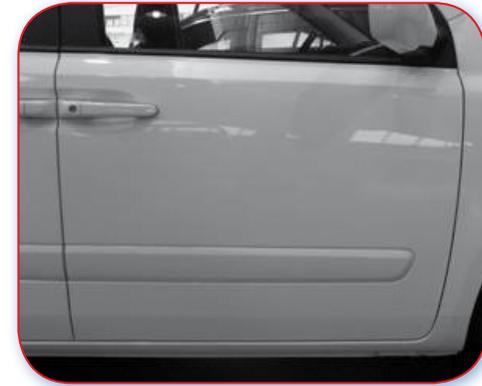
Poor Example. A moulding that does not cover the whole width of the doorskin does not allow painting of only part of the door.

Design for repair guidance: Fitting a moulding across the whole width of the door will avoid colour match problems when painting only part of the door. This contributes to a high quality finish and also to cost savings. The option to remove the exterior accessories on the door, such as the handle, lock, moulding and mirror, without the need to remove the door trim, will facilitate their removal for painting and avoid masking operations.

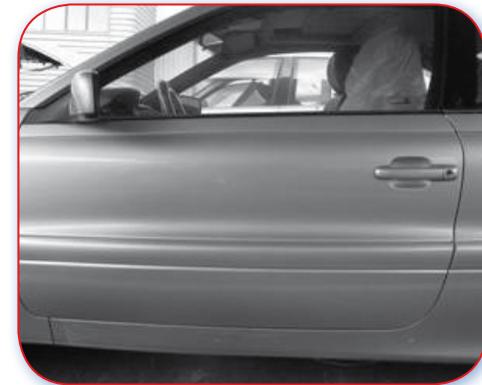
Good Example. A moulding across the whole door enables either the top or bottom of the door panel to be painted separately.

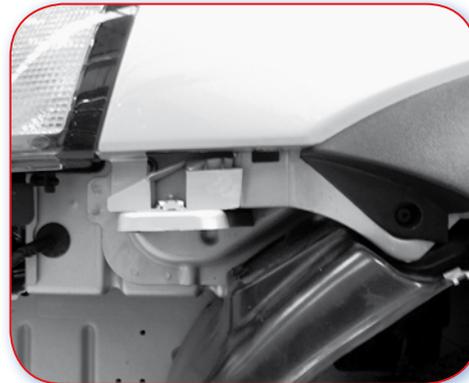
1.1.C Poor example. Bracket to carry bumper is fitted to panel.

Design for repair guidance: Either have bumper covers separate from panels or have sacrificial joints that will separate before any damage occurs to the panel (pic 1.1.C, 1.2.D).

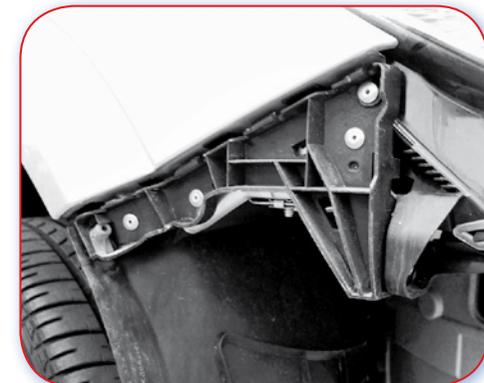
1.1.D Poor example. Bracket is supporting the panel and bumper independently. Fastener for the panel is covered by the bracket.

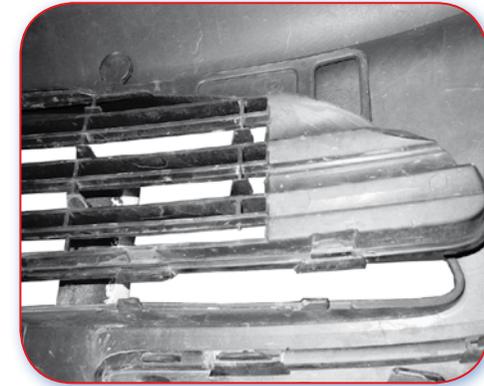
1.6.A Good example. Bumper grille can be removed for refit of new bumper.

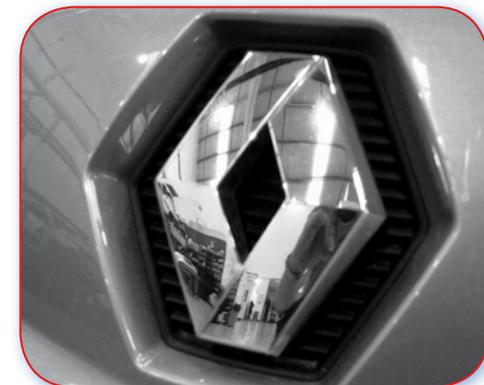
1.6.C Poor example. The badge fixed to the bumper panel and the fastener for the panel is covered by the bracket.

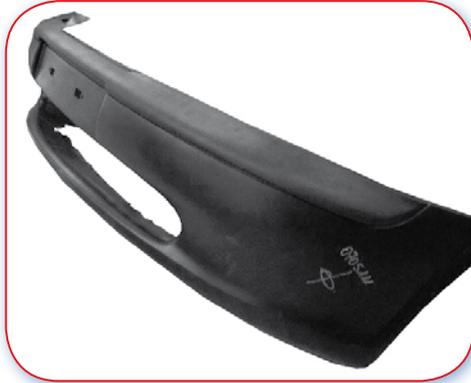
1.10.A Good example. Bumper will require fresh masking before paint.

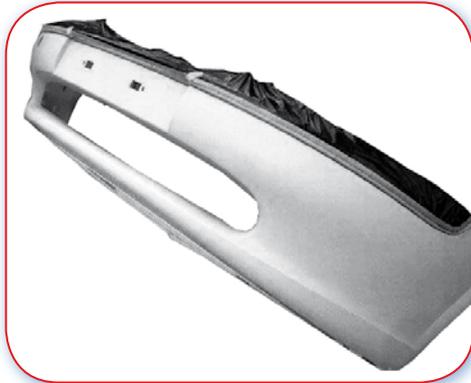
1.10.B Poor example. Pre-masked bumper; masking will age before part requires paint, so it will require re-masking.

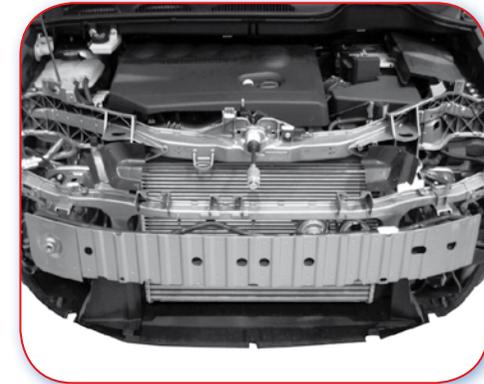
2.1.A Good example. Good distance between reinforcement and cooling pack. Good reinforcement height and no parts clip onto it.

Design for repair guidance: Increase the height of the reinforcement to have a sufficient area. Together with an average level, this will avoid excessive damage when override or underide occurs (pics 2.1.A, 2.1.B, 2.1.C).

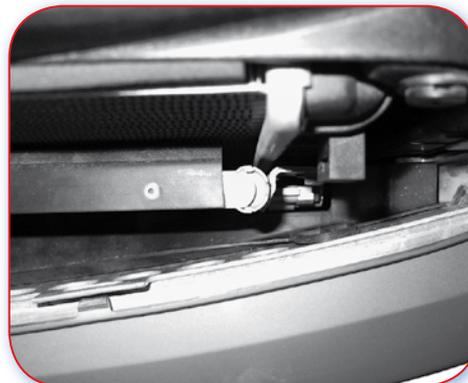
2.2.A Poor example. Not having enough distance between reinforcement and cooling pack - will cause damage to adjacent parts on impact.

Effect on repair: A small gap between the reinforcement and any parts behind it can result in the need to replace additional parts as they may be damaged by the intrusion of the reinforcement in a low speed accident (pic 2.2.A).

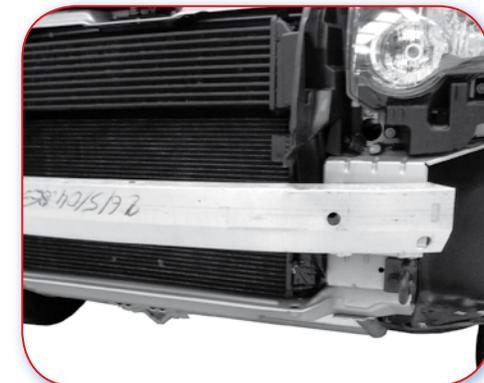
2.1.C Good example. Good reinforcement height. Good distance between bumper beam and cooling pack. Low pedestrian protection bar. No parts fixed to the bumper beam.

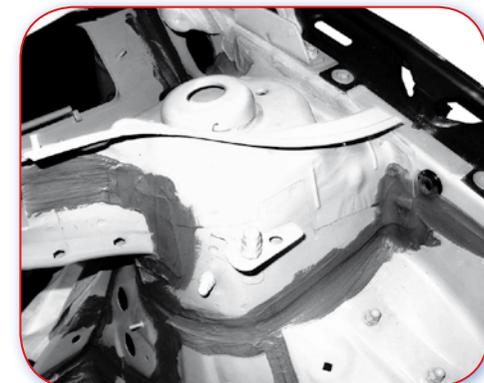
5.2.B Poor example. Suspension strut tower is positioned as part of the firewall plenum chamber.

Design for repair guidance: Ideally, a front suspension tower should be fitted as a panel by itself, but this may be difficult due to the amount of space and the set up of the suspension (pics 5.2.A, 5.2.B).

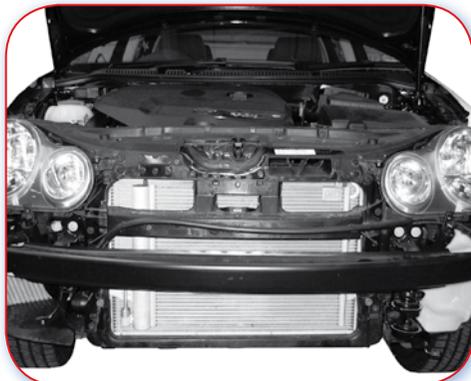
7.2.A Good example. Bolt-on front panel made out of reinforced plastic.

Design for repair guidance: The landing panel should have the ability to break away from its fixings. The panel should not be fitted to the bumper, crush cans or chassis leg. This will avoid damage when the vehicle has a low speed impact only affecting the bumper. An allowance for space should be made behind the panel to allow travel of the panel (pics 7.2.A, 7.2.B, 7.2.C, 7.2.D, 7.2.E, 7.2.F, 7.2.G, 7.2.H, 7.2.I, 7.2.J, 7.2.K, 7.2.L).

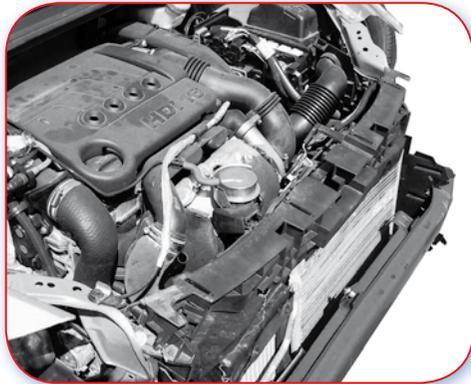
7.2.D Good example. Bolt-on front panel made out of reinforced plastic.

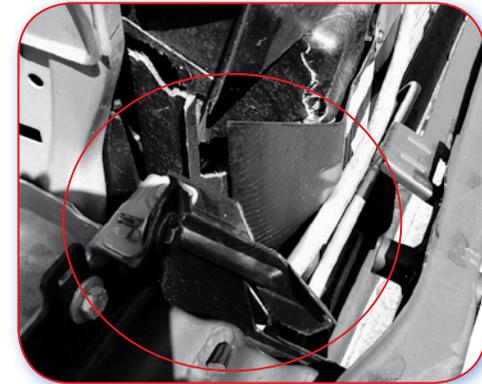
7.2.F Good example. This panel can be replaced easily. The cooling pack can move, but will not be damaged on impact.

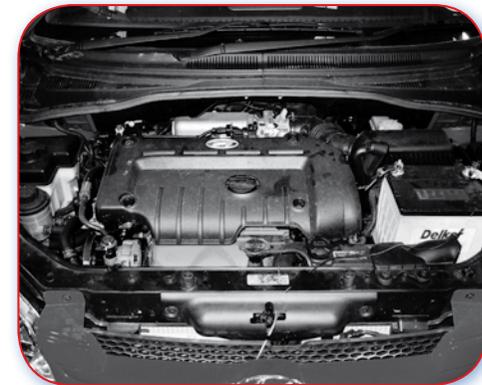
7.2.H Good example. The front panel comprises a landing panel but no lower parts. Costly parts set back enough to reduce damage.

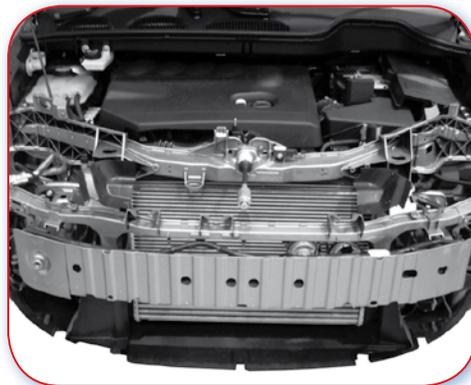
7.2.I Good example. Front panel bolted on.

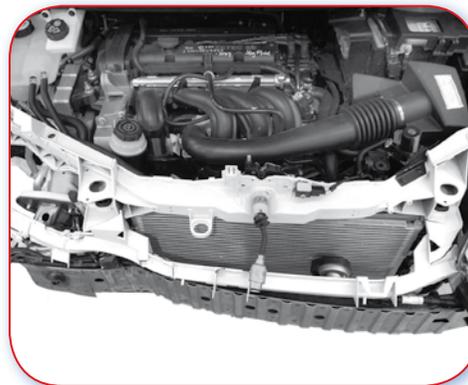
7.2.J Good example. Bonnet landing panel set back from the front bracket, avoiding subsequent damage.

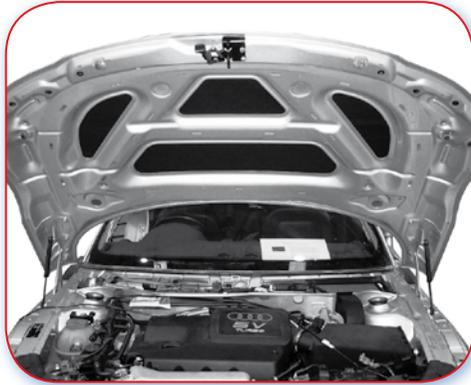
8.0.A Single skinned bonnet with reinforcing sub-frame, easier to repair as both panels are accessible.

Bonnets are becoming more service parts than repairable parts. This means that when a bonnet is damaged it gets replaced instead of being repaired, unless very minor damage like damaged paint or damage to plastic inserts occurs. This is also reinforced by the new pedestrian safety regulations, which are pushing car designs towards a single or a double skinned part, without any reinforcements in the centre part of the panel. This means that repair of these parts has become more or less obsolete (pics 8.0.A, 8.0.B, 8.0.C).

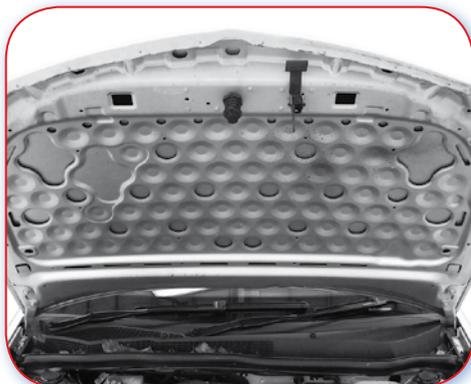
8.0.C Double skinned bonnet without reinforcing frame, compliant with the new pedestrian legislation. More difficult to repair, due to limited access to both panels.

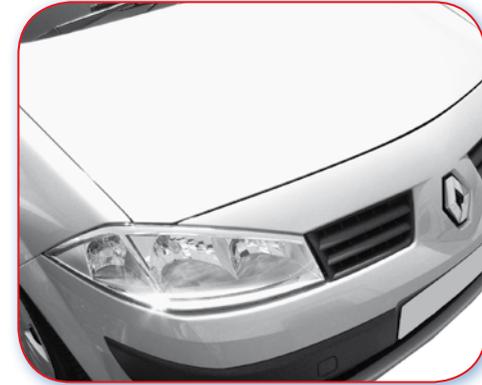
8.1.A Good example. See pic 8.1.B.

Effect on repair: Exposure of the bonnet affects how much it will be damaged during a frontal impact (pics 8.1.A, 8.1.B).

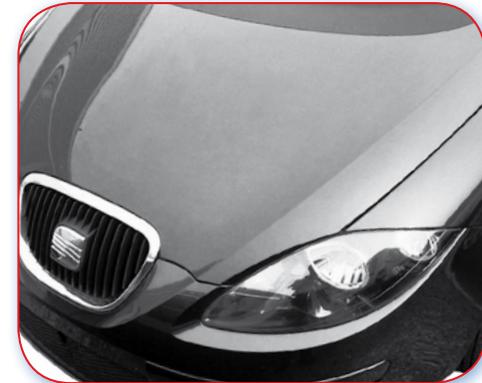
8.1.B Good example. Front edge of bonnet set back. Side edges protected by side panel.

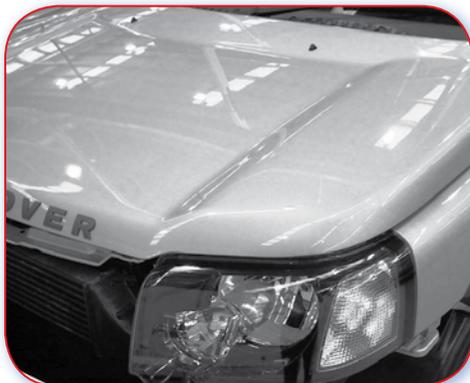
8.1.C Poor example. Wrap around bonnet which results in more exposure to damage.

Design for repair guidance: Wrap around bonnets should be avoided as they will be more exposed to damage. Bonnets that are set back are better in a low speed frontal impact, as the bonnet will be less affected (pics 8.1.C, 8.1.D).

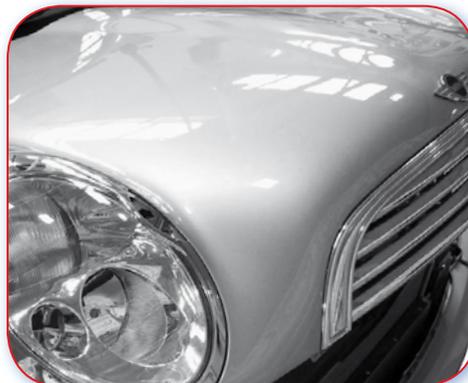
8.1.D Poor example. See pic 8.1.C.

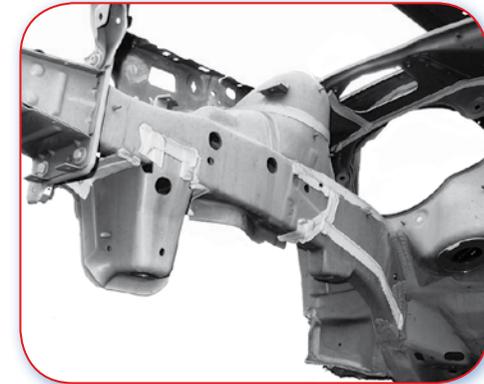
9.3.A Good example. These pictures show chassis legs with natural joints near the firewall for complete replacement.

Design for repair guidance: Provide a natural joint near the plenum chamber/firewall to allow repair on the chassis legs (pic 9.3.A, 9.3.B).

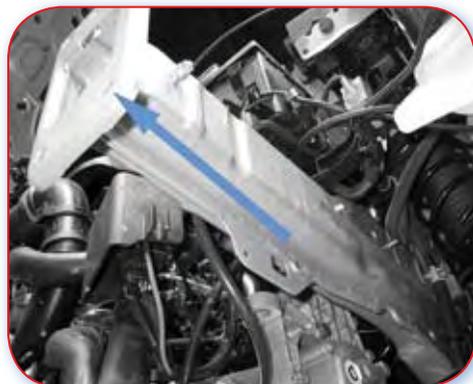
Poor Example. Front chassis leg without a central data point, does not have a suitable reference to control pulling operations.

Effect on repair: The lack of measuring points reduces accuracy when straightening the chassis legs.

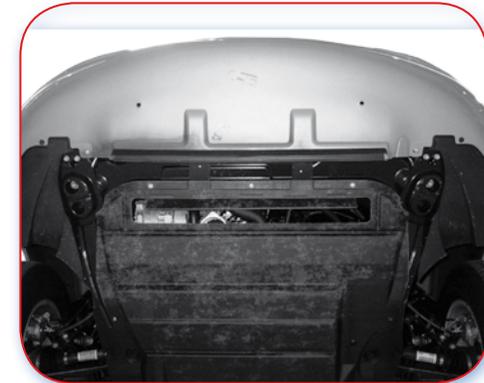
11.3.A Good example. Under tray covering engine bay, fixed with hexagonal head screws, not breakable clips or staples.

Effect on repair: The under tray is difficult to separate from the bumper, when removing either the front bumper or the under tray, if the joint is made using staples or rivets.

Design for repair guidance: Use removable fixings such as screw fasteners or clips (pic 11.3.A).

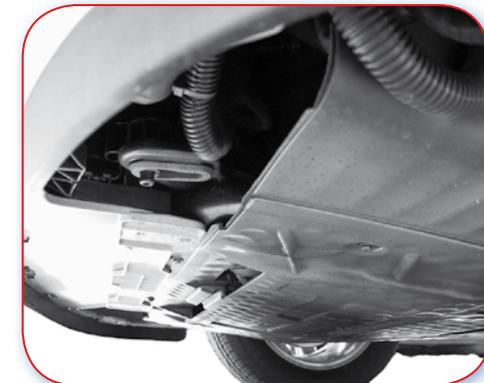
11.1.A Good example. Under tray fixed to lower bumper, but built in several segments.

Effect on repair: Under trays which are reinforced to support lower parts of the bumper and front panel, as part of pedestrian protection, will be damaged on impact and require complete replacement in repair. This will increase the repair costs.

Design for repair guidance: Design the tray as a two piece part where a damaged front part can be easily replaced (pic 11.1.A).

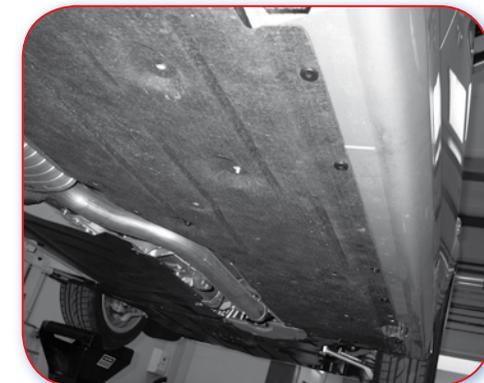
Poor Example. Covers under the vehicle will hinder the diagnosis and measurement of damage, as well as anchoring to the jig.

Effect on repair: Streamlining panels cover up anchoring and measuring points, so these panels must be removed before any anchoring or measuring can be done, increasing labour times.

Design for repair guidance: Avoid restricting any access to measuring and anchoring points.

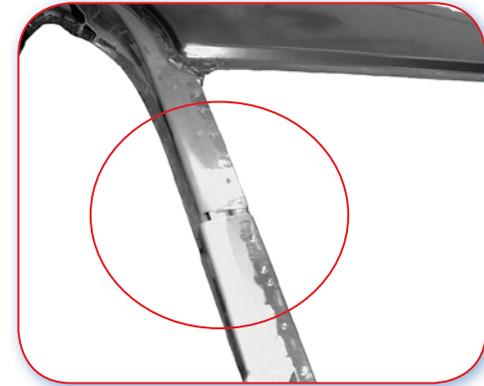
12.0.C Good example. 'A' Post reinforcement is sectionable at natural joint in upper part, avoiding complete removal.

The 'A' Post forms the outer front edge beside the front screen and runs all the way down to the sill, behind the front outer wing and also supports the roof. It normally contains reinforcements made of UHS steels, creating load paths that separate loads into the roof line and sill around the passenger cell. It is generally strong enough to resist a roll over of the vehicle without the roof intruding into the passenger cell (pics 12.0.A, 12.0.B, 12.0.C, 12.0.D).

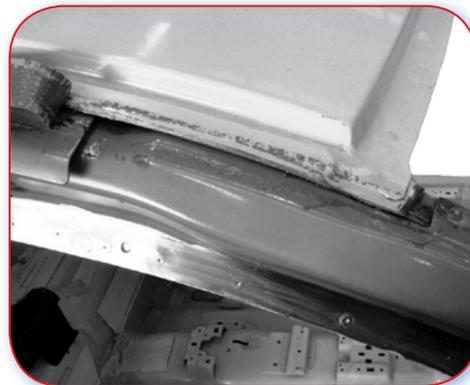
12.1.D Good example. Outer panel fitted over roof panel.

Design for repair guidance: A bridging panel would be better, having the side panel reinforcement and 'A' Post butting against each other. This will ease the removal of the 'A' post and reinforcements, as there will be no requirement to remove adjacent panels (pics 12.1.A, 12.1.B, 12.1.C, 12.1.D, 12.1.E).

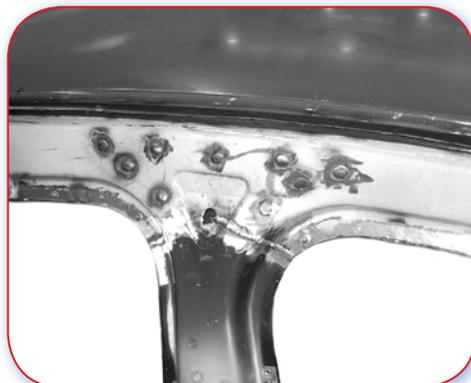
13.0.C 'B' Post has to be sectioned and roof rail has to be opened to allow the reinforcement to be fed between the panels, avoiding damage to the reinforcement due to space restrictions.

Sills and 'B' Posts have a range of functions within a vehicle. They provide rigidity and stiffness to the body and are normally made up from several layers, including one or more reinforcements. The sill is the lower visible panel and forms, or carries the aesthetic panel between the front and rear wheel arch. The 'B' Post also forms the main structural protection for occupants against a side impact. Because the 'B' Post and sill are physically joined, a repair to either of these parts indirectly affects the other (pic 13.0.A, 13.0.B, 13.0.C, 13.0.D, 13.0.E).

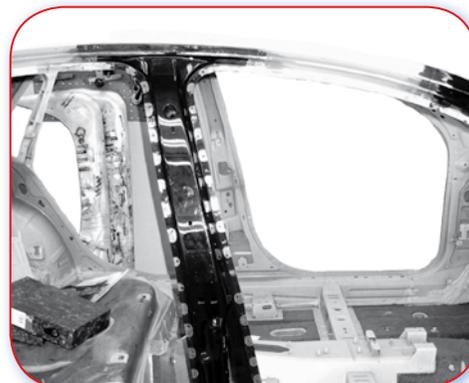
13.0.D 'B' Post cannot be sectioned so the roof rail has to be opened to allow the 'B' Post panel with its 'non-weldable' press hardened reinforcement, to be fitted onto the roof rail and sill.

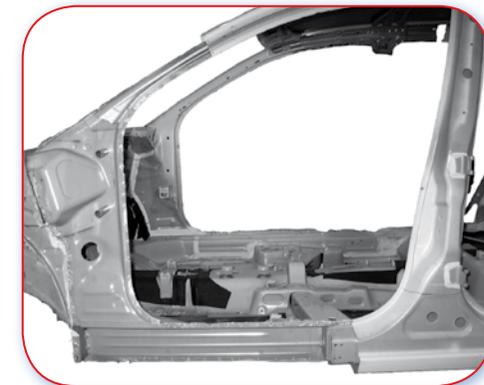
13.1.C Good example. 'A' Post cover and reinforcement where it joins the sill which are sectionable, making removal of the 'A' Post reinforcement easier and allowing for sectioning of the sill.

Design for repair guidance: The possibility of removing sill reinforcements without extensive removal of other parts is recommended. This can be achieved by having reinforcements made out of sections, allowing partial removal and reducing labour times and parts (pics 13.1.A, 13.1.B, 13.1.C).

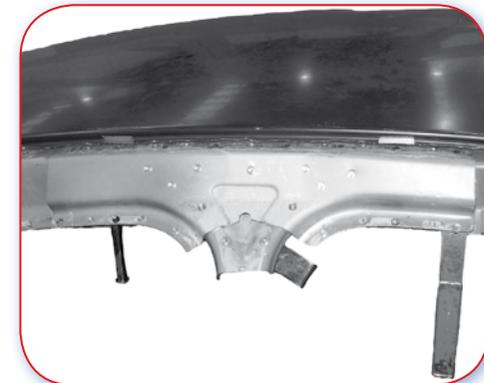
13.2.F Poor example. 'B' Post has to be sectioned and roof rail has to be opened for the reinforcement to be fed between panels.

Design for repair guidance: Introducing a smaller local UHSS reinforcement fitted to a lower strength full panel serviced as an assembly will allow sectioning of the carrier panel (pics 13.2.E, 13.2.F, 13.2.G, 13.2.H).

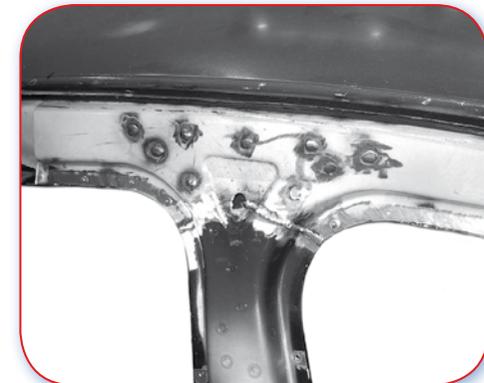
13.2.B Poor example. Damage must be avoided to the reinforcement due to limited space between the outer panel and reinforcements.

Effect on repair: Their material characteristics do not allow reinforcements made of UHSS to be sectioned and then welded. When the reinforcement is joined to both the sill and the roof, it requires a complete replacement. This means excessive labour times and parts requirements, as both the roof and the sill have to be opened up. More paint work will also be required, due to the increased repair area (pics 13.2.A, 13.2.B, 13.2.C, 13.2.D).

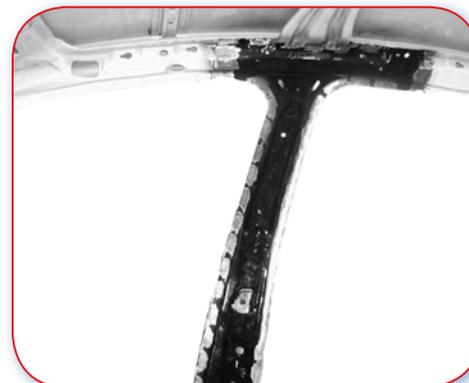
13.2.C 'B' Post cannot be sectioned so the roof rail has to be opened to allow the 'B' Post panel with its 'non-weldable' press hardened reinforcement, to be fitted onto the roof rail and sill.

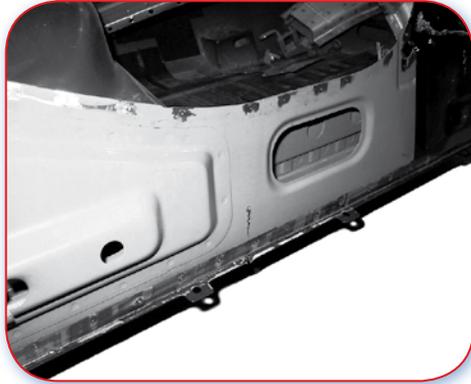
13.4.A Good example. See pic 13.4.B.

Effect on repair: When sill panels are joined to the chassis or the floor, a single joint is preferred over a bridging panel joining the sill panel and floor, as this reduces accessibility. It makes repair awkward when both panels are damaged and increases repair times (pics 13.4.A, 13.4.B).

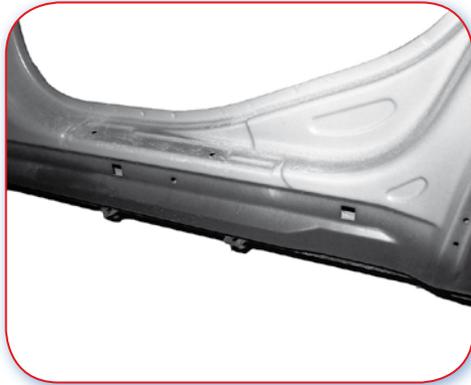
13.4.B Good example. Sill cover panel runs from edge to edge over the reinforcement around the 'B' Post and rear reinforcement.

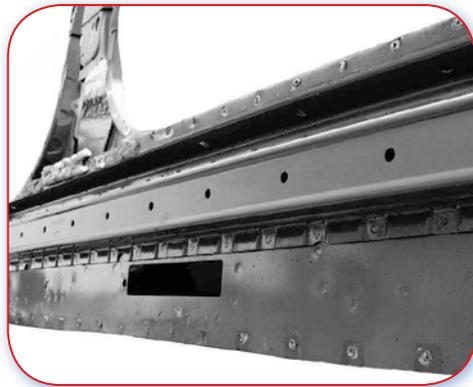
13.5.B Poor example. Sill reinforcement is a single piece and when damaged will require sill cover removal and sectioning.

Effect on repair: Sill reinforcements made from a single piece require extensive removal of both the sill cover and the reinforcement when damaged (pics 13.5.A, 13.5.B).

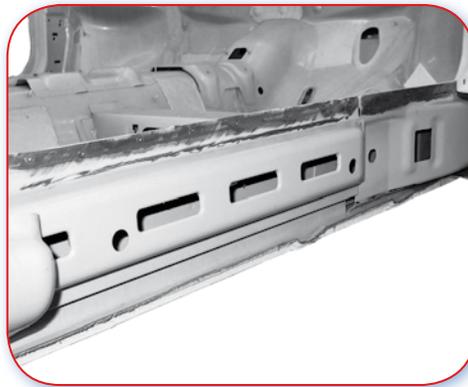
13.5.C Good example. Sill reinforcement is made of separate parts and can be repaired by partially removing the sill reinforcement.

Design for repair guidance: Design sill covers as cosmetic panels only which can then be removed easily. Reinforcements should be made out of separate parts to limit the requirement for removal. This will reduce repair times and makes repair easier (pics 13.5.C, 13.5.D, 13.5.E).

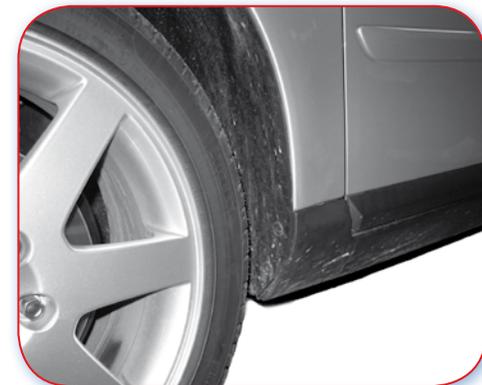
13.5.D Good examples. Sill cover panel runs from front edge to rear edge, over the reinforcement and around the 'B' Post and rear reinforcement. Sill shape is given by fitting a plastic cover.

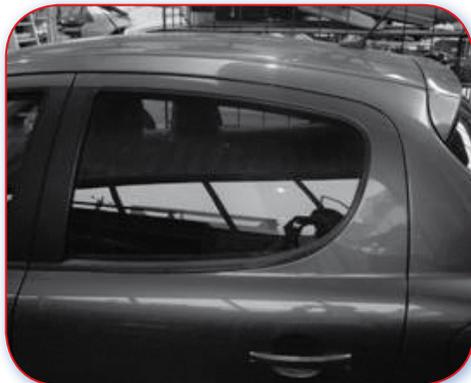
Poor Example. A doorskin with window frame will be difficult to replace.

Effect on repair: A doorskin that surrounds the window is more difficult to replace due to its complex shape.

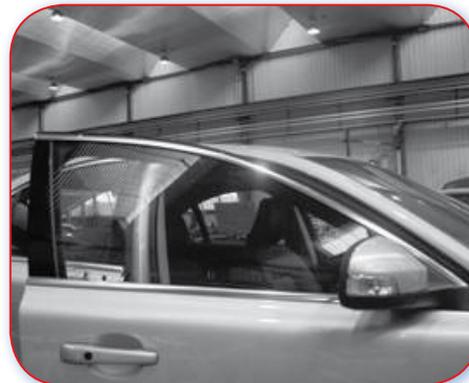
Good Example. A doorskin without its own upper window frame will make doorskin replacement easier.

Design for repair guidance: Avoid complicated door skin shapes surrounding windows.

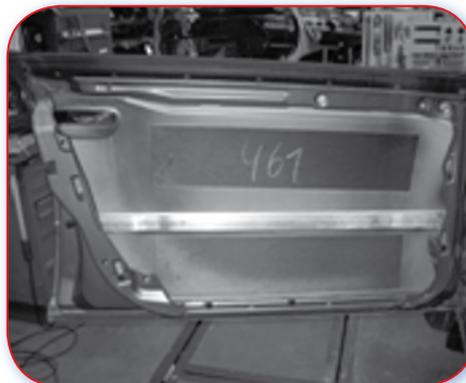
Good Example. Good accessibility for panel beating operations. The side impact protection bar is mounted by bolts, so it is possible to remove it to improve the accessibility.

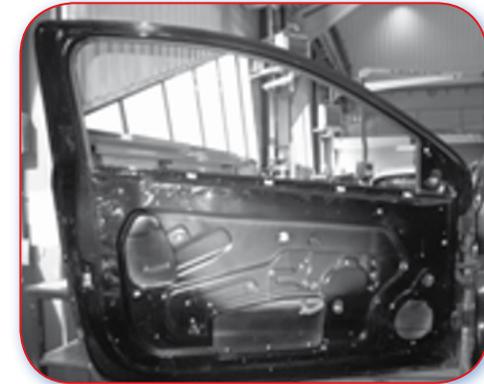
Poor Example. The limited access through holes in the door frame makes repair difficult.

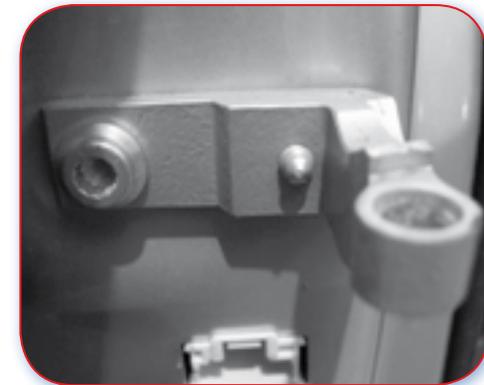
Poor Example. The limited access through holes in the door frame causes problems in repair.

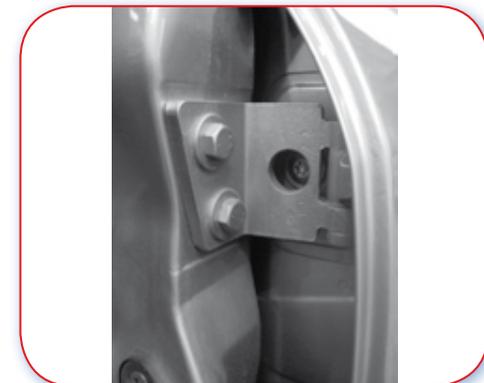
Good Example. Good accessibility for panel beating operations. The side impact protection bar is mounted by bolts, so it is possible to remove it to facilitate access.

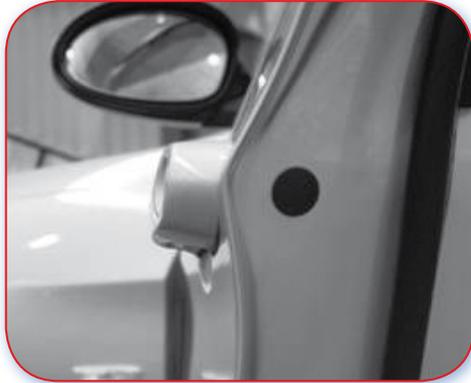
Poor Example. A doorskin with the curvature inwards makes it difficult to repair and paint.

Design for repair guidance: Good access should be available to the door inner frame, so it can be worked on properly. Avoid an inward curvature on the doorskin, as it would hinder the repair and paint operations. To have a screwed central frame, on which the door mechanisms are fixed, would allow the removal of the entire system, which would reduce labour times. To have separate access covers in the door trim allows the removal and adjustment of the window, without needing to remove the door trim completely. This will reduce labour times.

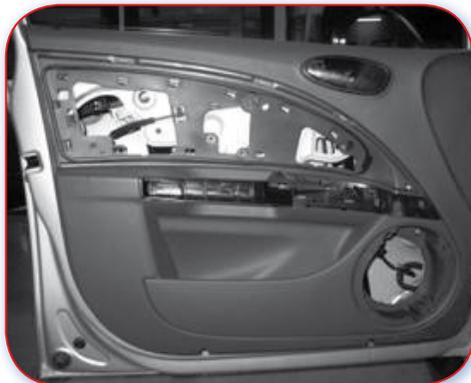
Good Example. A door trim with separate access covers will facilitate the disassembly and adjustment of door mechanisms without the need to remove trim.

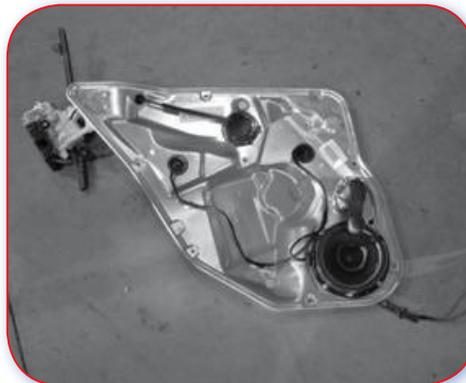
Good Example. The door has a screwed central frame, on which the various door mechanisms are fixed. This will allow the removal of the entire set, saving labour times.

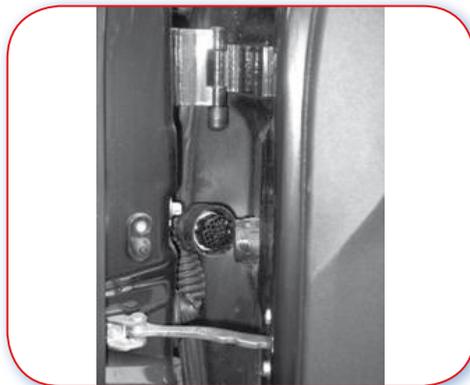
Good Example. A central electrical multi-connector will make it easier to remove the door.

Design for repair guidance: All the electrical wiring should have a centralised multiple connector, which will allow all electrical devices to be disconnected at the same point. This will allow the door to be removed as easily as possible.

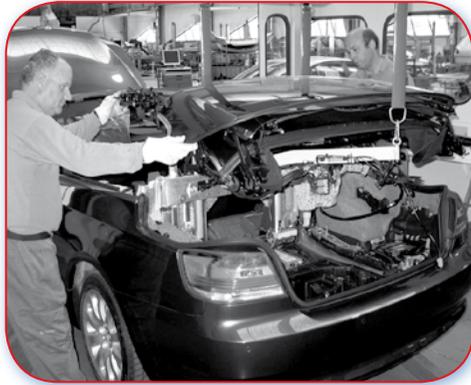
15.1.A Poor example. Removal of the complete roof in stowed position is difficult due to the shape and available space.

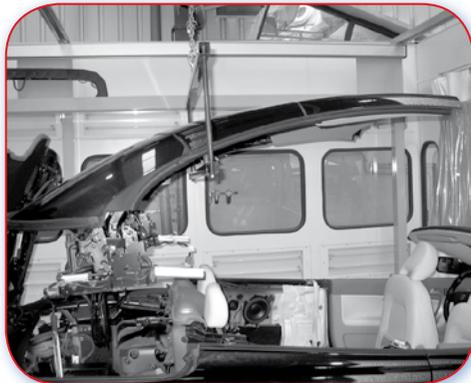
15.1.C Good example. The whole assembly is easily removed from the vehicle due to availability of moving space.

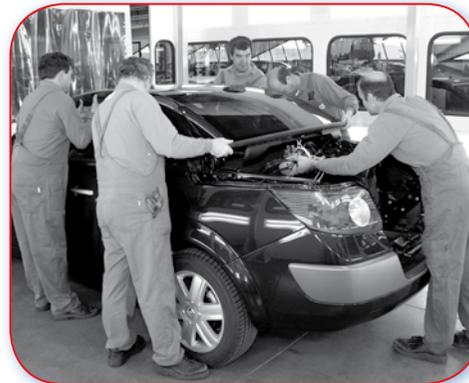
15.2.A Poor example. Removal and assembly requires several people.

Effect on repair: The need to lift the folding roof assembly from the car using several people is time consuming. In general, the need to operate in an awkward position increases the risk that the car will be damaged.

Design for repair guidance: The use of special tooling for lifting and removal of the folding roof will eliminate the need for several people to lift it and reduce the risk of damaging the vehicle.

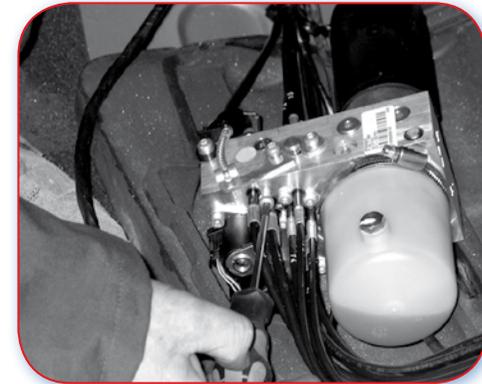
15.3.A Poor example. Hydraulic system to be drained before separation of the system from the folding roof.

Effect on repair: Using an electro hydraulic system means on some occasions that the hydraulic pump needs to be separated from the rest of the system with the risk of oil spillage into the car.

Design for repair guidance: Avoid the requirement to separate the hydraulic system from the rest of the folding roof when removing from the car. Instead, the removal of the complete system is preferred.

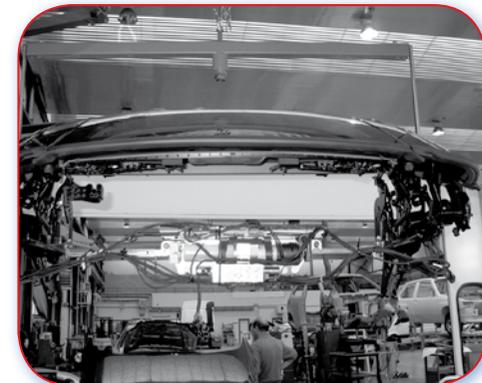
15.3.B Good example. The complete assembly, including electro hydraulic system, can be removed.

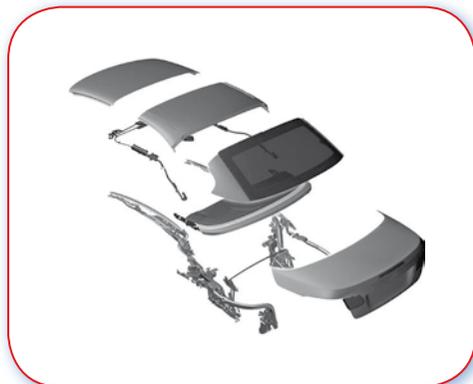
15.4.A Poor example. Folding roof assembly consisting of more than three panels.

Effect on repair: The more sections a roof has, the more difficult it is to adjust both the roof itself and the roof position in relation to the car. The option to adjust is necessary, as this will reduce the gap sizes to make the car watertight and to reduce any wind noise during driving.

Design for repair guidance: It is preferred to have a folding roof with the smallest number of sections possible.

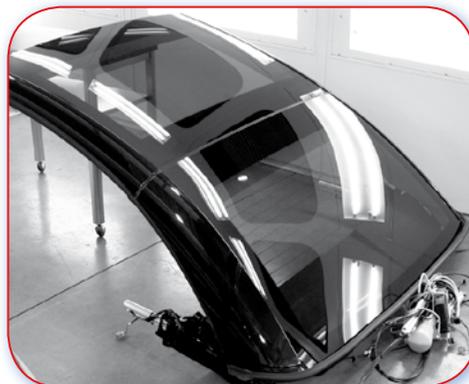
15.4.B Good example. Folding roof assembly consisting of two panels.

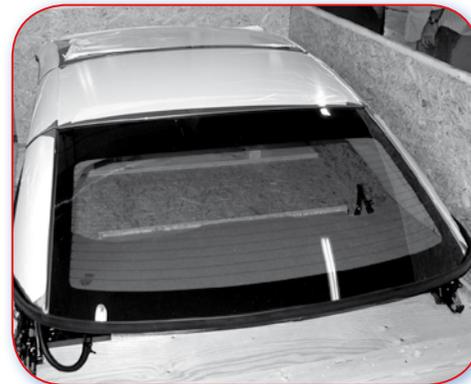
15.7.A Good example. Full folding roof assembly, as well as small part assemblies available for repair.

Effect on repair: The availability of a full assembly, complete with painted panels, assists the replacement of a damaged system and will reduce costs.

Design for repair guidance: Having the assembly available as a service part does not mean that separate parts should not also be available. If this is not the case, it could increase the cost of repair significantly.

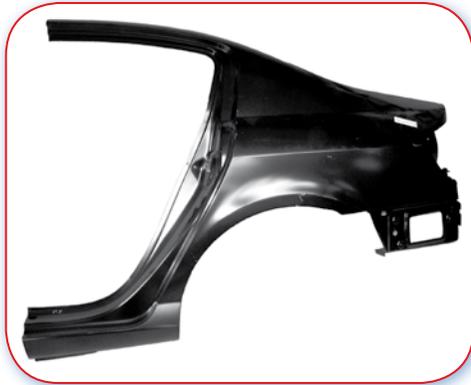
16.1.B Good example. Service parts supplied as a whole rear segment to cover the most vulnerable parts like the dog leg.

Effect on repair: Service parts are normally available as separate panels. Although this is in principle a good solution, the reality is that outer panels are cut from whole body sides and the location of the cuts varies, resulting in service panels not joining accurately. Also damage to the vehicle may occur between areas covered by two service panels (e.g. panels cut on the dog leg) (pics 16.1.A, 16.1.B, 16.1.F, 16.1.G, 16.1.H, 16.1.I, 16.1.J).

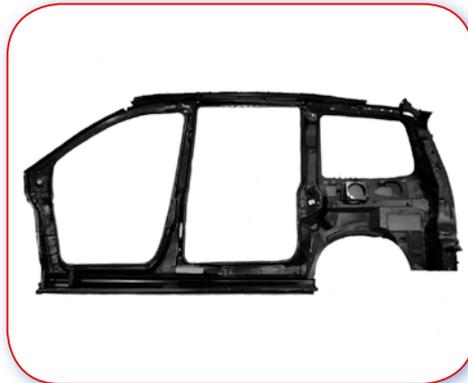
16.1.C Good example. Service parts supplied as a whole that can be cut where required to suit the damage to the vehicle. This avoids any mismatching joints.

Design for repair guidance: The servicing of a sympathetically priced whole body side panel avoids discrepancies on joints and also allows the repairer to cut the best section for each repair. Parts of panels can be separated out of the whole body side and accurately positioned according to the damage on a particular vehicle (pics 16.1.C, 16.1.D, 16.1.E).

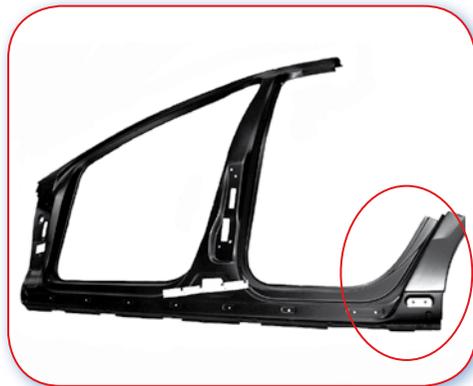
16.1.G Poor example. Service parts supplied as a side panel segment but having a joint at one of the most vulnerable and most frequently damaged parts like the dog leg.

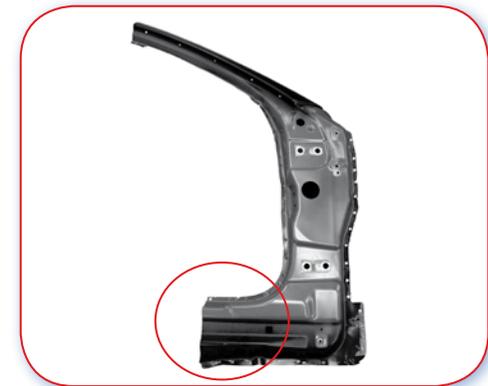
16.1.J Poor example. Service parts supplied in separate units need joining up when fitting, unless the part covers the damaged area.

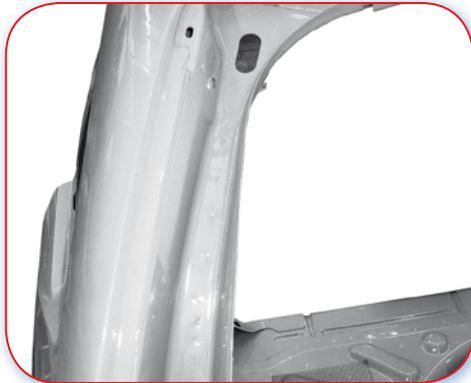
17.1.B Good example. Drain channel made out of one piece, joining outer and inner panel.

Design for repair guidance: The rear quarter panel is the most vulnerable panel in this area and removal of this panel without the removal or sectioning of undamaged surrounding panels should be possible (pics 17.1.A, 17.1.B, 17.1.C, 17.1.D).

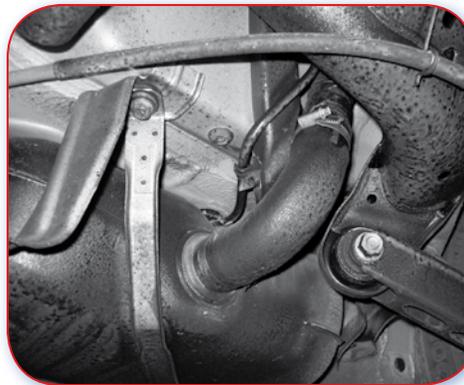
17.3.A Good example of a filler neck.

Design for repair guidance: To avoid the need for the fuel tank to be drained and capped before any heat (welding and painting process) is applied, it would be better to be able to separate and remove both the tank and filler neck (pic 17.3.A).

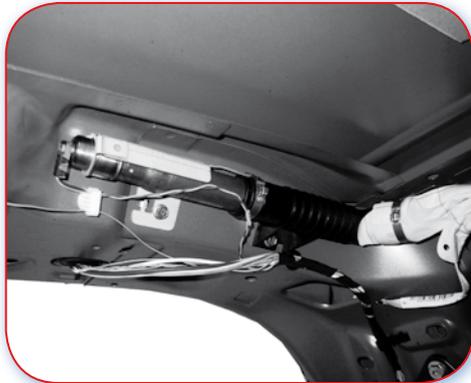
17.4.B Good example. As the curtain airbag generator is fitted onto the upper roof joint, removal is not required during repair.

Design for repair guidance: Have airbags fitted in a position less prone to damage, which will avoid excessive labour costs in repair (pics 17.4.A, 17.4.B).
