RCAR Design Guide - A manufacturers' guide to ensure good design practice for repairability and limitation of damage.

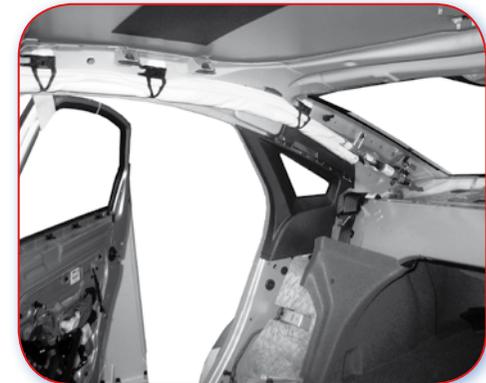
17.4.D Poor example. As the curtain airbag generator is fitted onto the rear roof joint, removal is required during repair.

Effect on repair: Curtain airbags tend to have the gas generator fitted on the inside of the upper rear quarter panel. This means that when removal or sectioning of the rear quarter is required, the whole airbag unit has to be removed, together with the headlining. This is labour intensive and there is the risk that the removed parts may be damaged, and may not be refitted correctly (pics 17.4.C, 17.4.D).

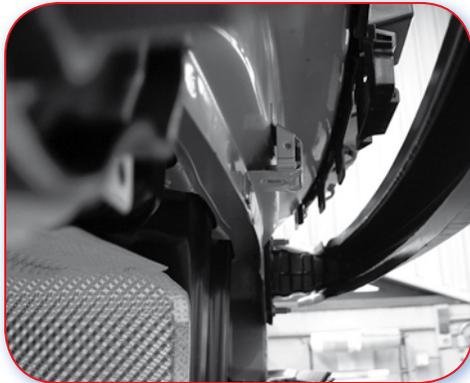
Good Example. Rear centre panel with the flange pointing downwards facilitates drilling and welding operations.

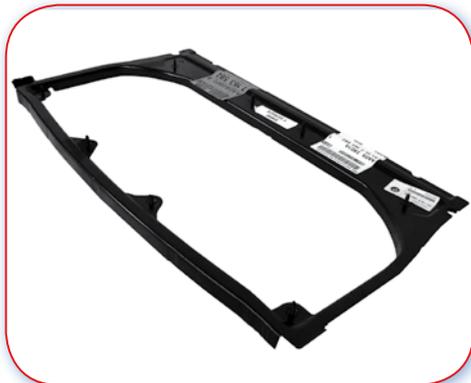
19.0.B Good example. Boot floor area in BIW without reinforced plastic infill and service repair part.

The boot floor is normally a fill in panel made out of reinforced plastics or steel, usually holding a spare wheel or equivalent. More of these panels are added to the body as a trim panel after the body has been built. This is obviously an advantage in repair as it keeps labour time down (pics 19.0.A, 19.0.B, 19.0.C, 19.0.D).

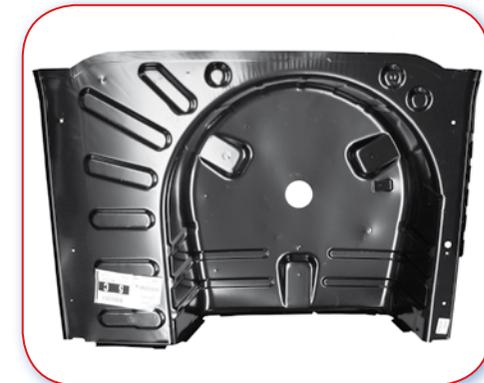
19.0.D Poor example. Boot floor area in BIW without reinforced plastic infill and service repair part.

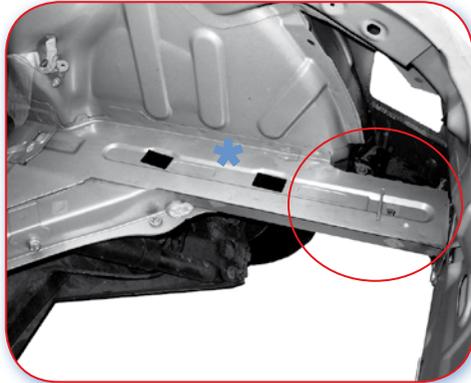
20.3.E There is enough space on the leg to deform in an impact, and enough space between the leg and wheel arch to remove the leg.*

NOTE 1: Repair on chassis legs is made easier when accessibility is improved. Vehicles with a plastic inserted boot floor are preferred, as these are easily removable and there is space in which to work (pics 20.3.E, 20.3.F, 20.3.G).

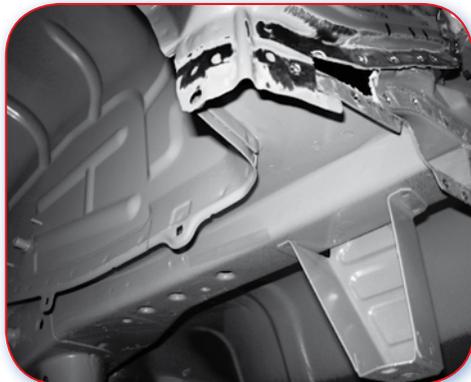
20.3.F There is enough space on the leg to deform and enough space between the leg and wheel arch to remove the leg.

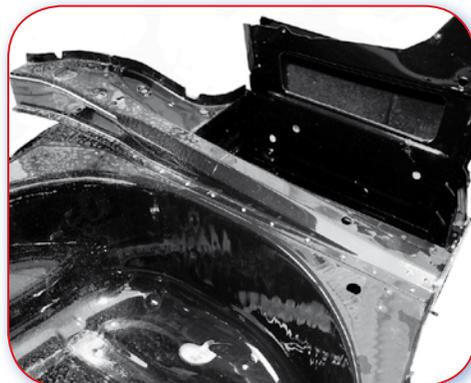
20.3.B Poor example. The chassis leg is part of the boot floor and therefore difficult to take apart.

Effect on repair: Chassis legs sandwiched between or as part of the wheel arch, boot floor and other closing plates or reinforcements should be avoided, as removal will take longer (pics 20.3.A, 20.3.B, 20.3.C, 20.3.D).

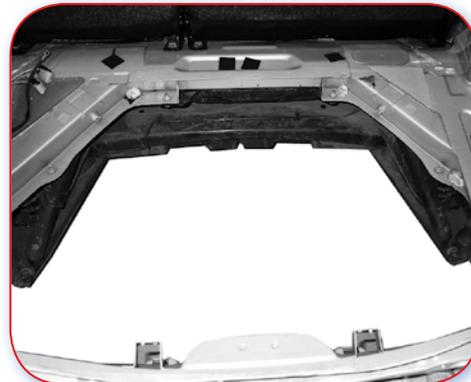
20.3.G Note 1. Good example. Ample access after plastic boot floor insert has been removed.

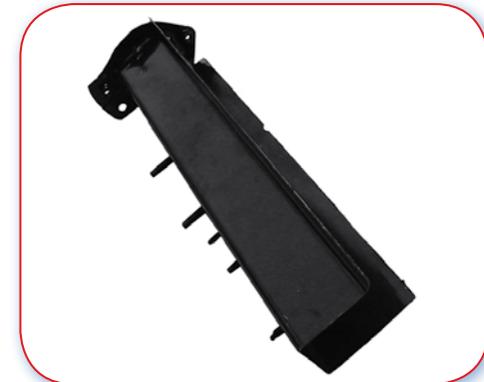
20.3.A Note 2. Good example. Service part for rear chassis leg.

NOTE 2: The fittings on service parts should match the joining method and align with the natural joints.

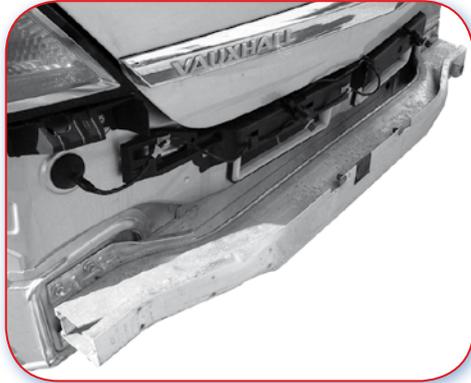
22.0.C Slight deformation of the beams.

The position and type of material can influence the damage caused by a low speed impact dramatically (pics 22.0.C).

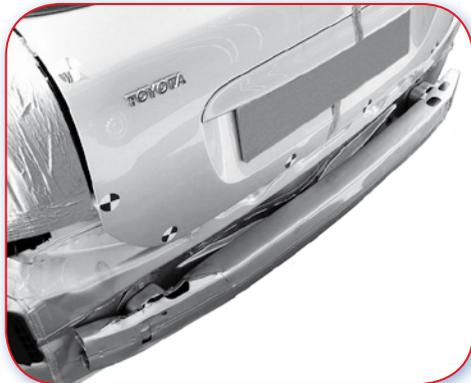
22.0.A Beam has been pushed forward, deforming the rear panel slightly.

There are the same service parts requirements as for the front bumper. The fixing points of the bumper should be independent from the rear outer panel to avoid subsequent damage when the bumper is pushed up (pics 22.0.A, 22.0.B).

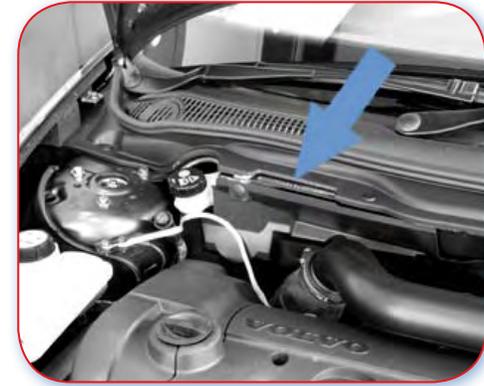
23.1.A Good example.

Repair parts are defined as parts that could typically be replaced as part of the repair strategy. These parts should be avoided when stamping VIN numbers or other vehicle specific information (pics 23.1.A, 23.1.B, 23.1.C, 23.1.D, 23.1.E, 23.1.F, 23.1.G).

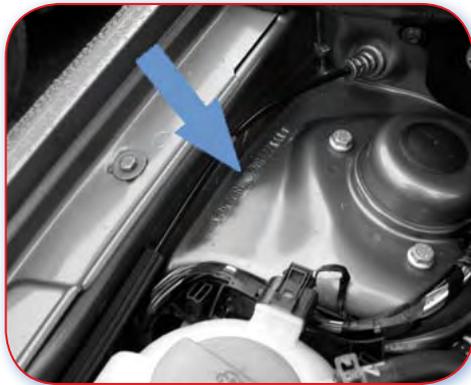
23.1.B Poor example.

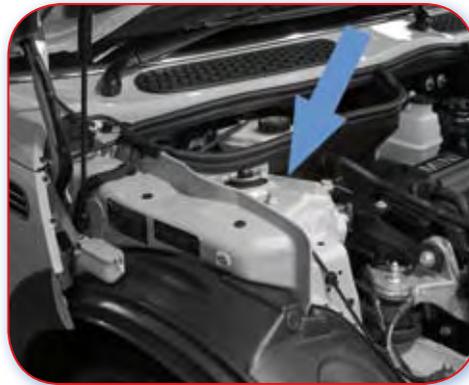
23.1.C Poor example.

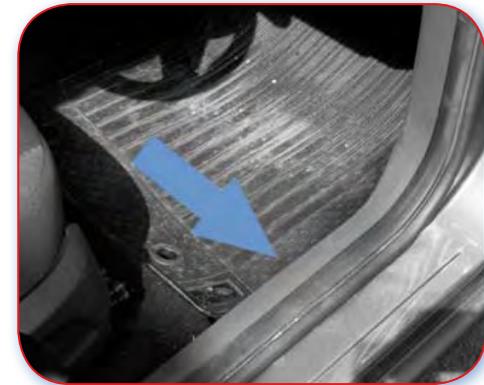
23.1.D Good example.

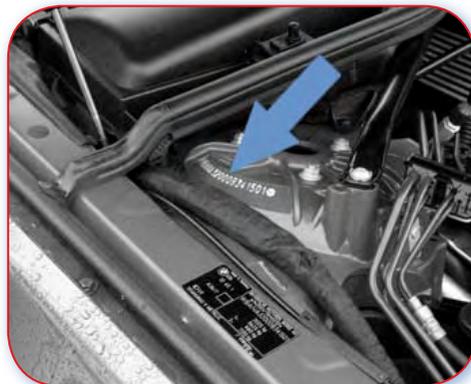
23.1.E Poor example.

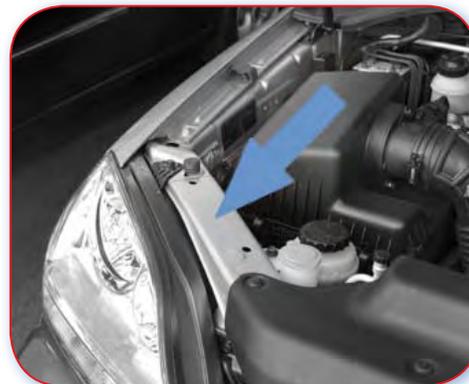
23.1.F Poor example.

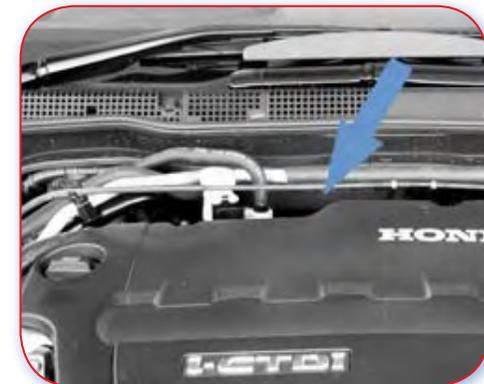
23.1.G Good example.

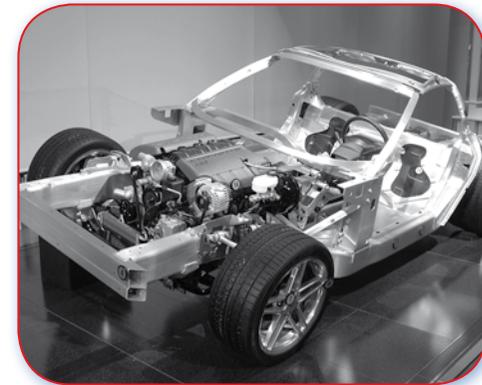
2.1.1 General example of a perimeter frame body.

Three main types of BOF designs exist – perimeter and hydro-form frame, which are found in passenger car and light truck applications, and ladder frame, which is primarily utilised for larger commercial or bus applications. Perimeter and hydro-formed frames have the frame and the unitised structure working in conjunction with each other to provide structural support, while the ladder frame is, by design, far more rigid and does not rely on the unitised structure for added strength.
